# 2019 INLAND WATER QUALITY REPORT

GUIDING THE TRANSITION TO A WATER-SENSITIVE FUTURE.

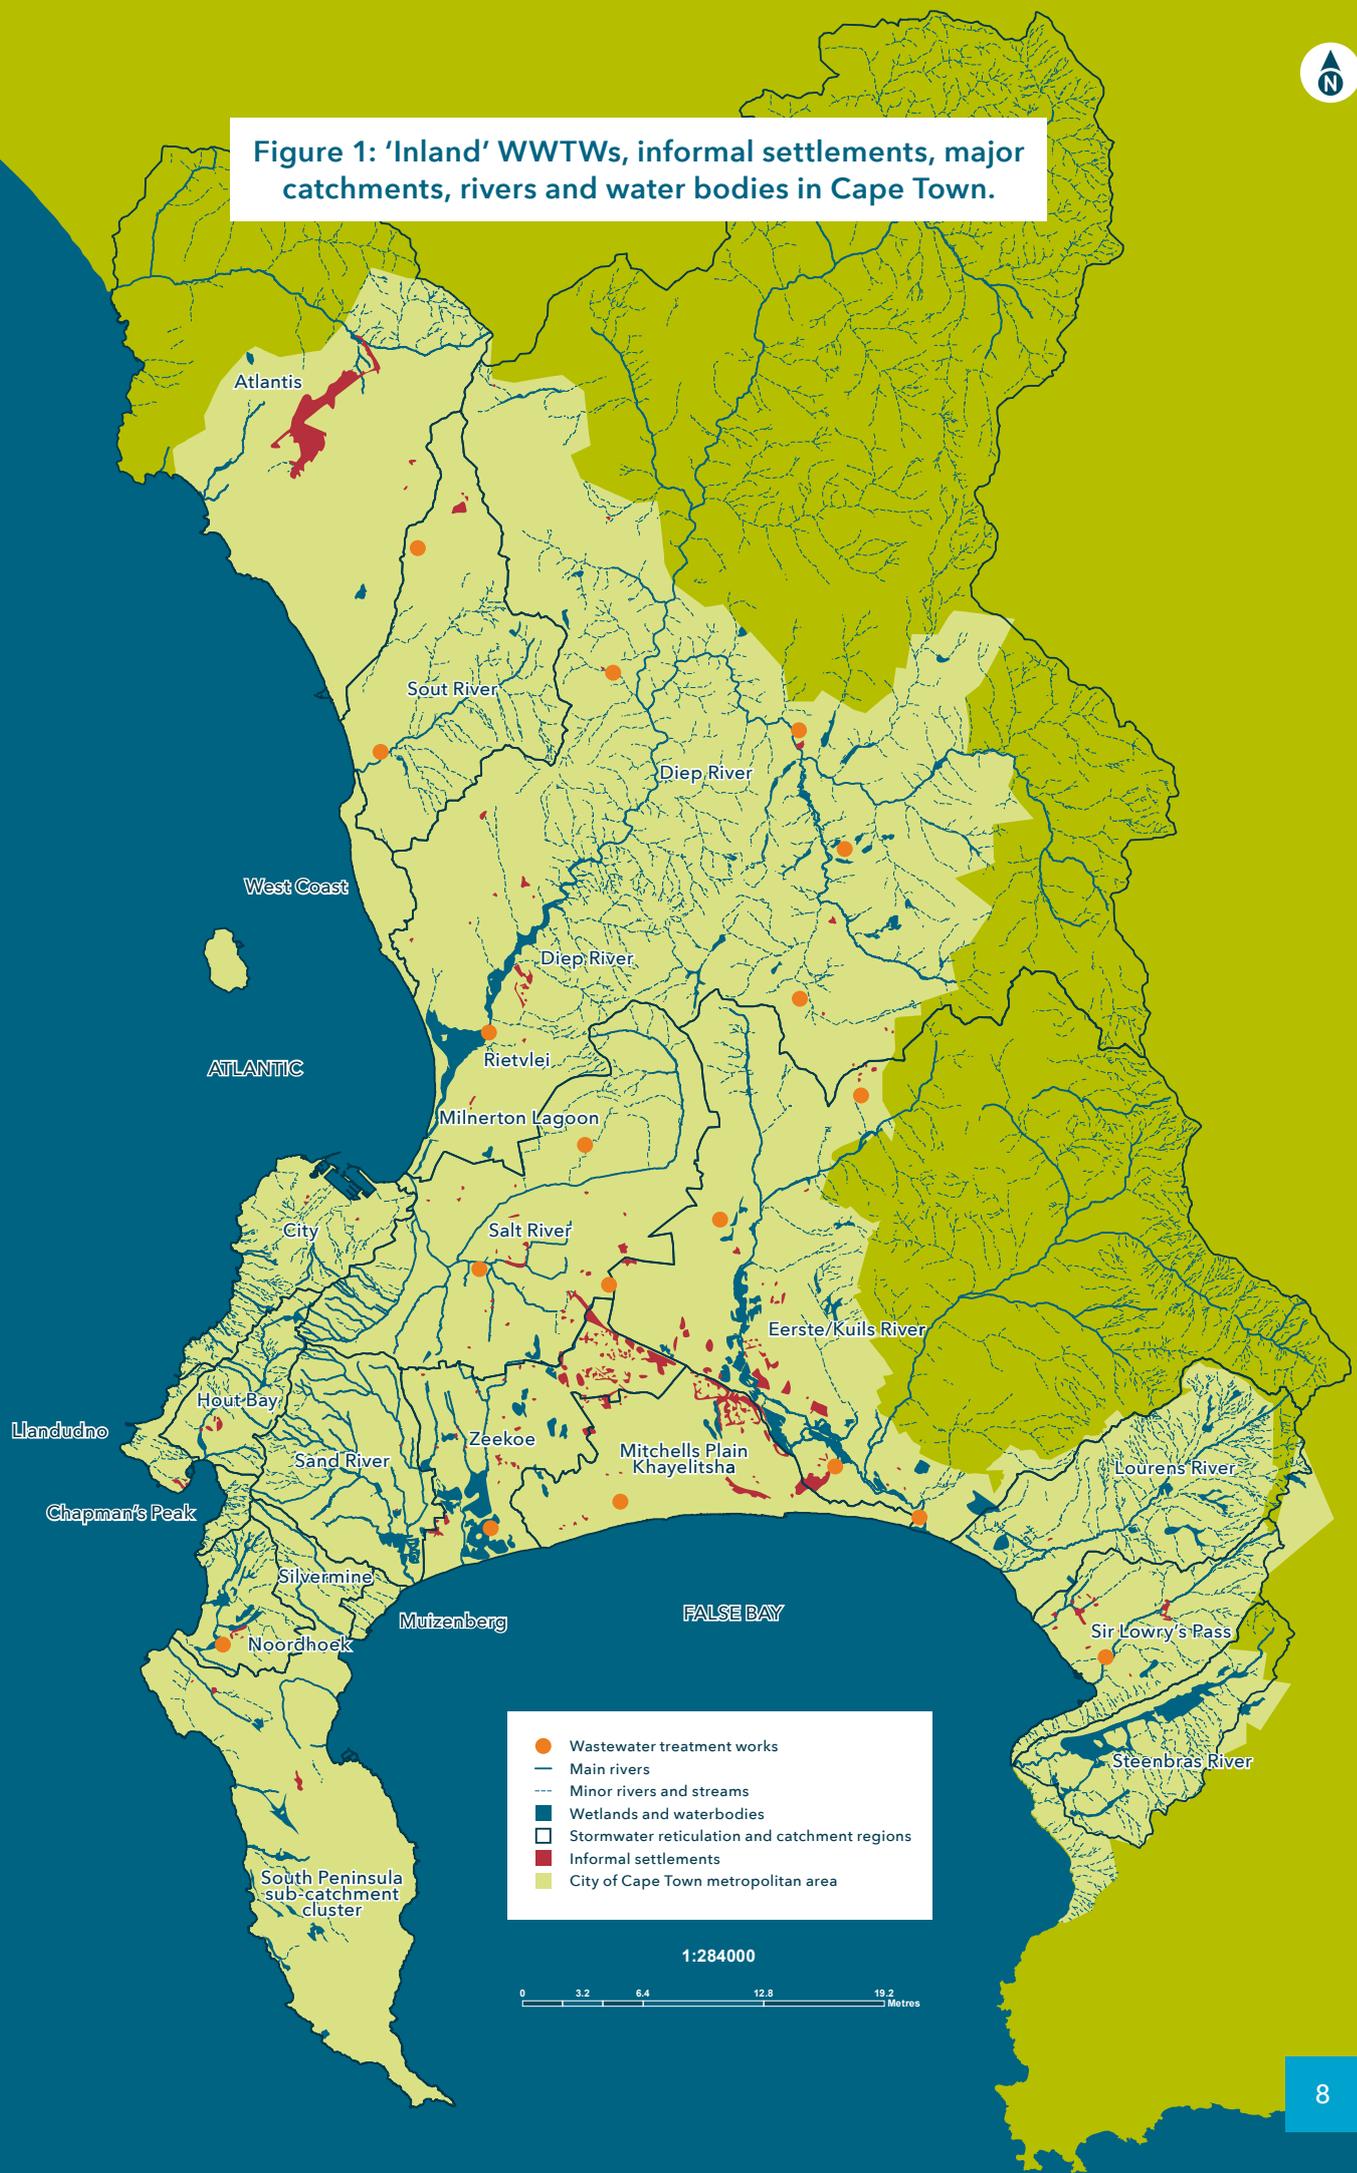
Figure 1: 'Inland' WWTWs, informal settlements, major catchments, rivers and water bodies in Cape Town.

Note that the Mitchells Plain catchment shown in figure 1 does not in fact (historically) include any natural watercourses. Water in this part of the Cape Flats probably infiltrated through the sand or formed shallow wetlands. Today, the area is largely developed. Runoff from the hardened urban surfaces is collected in large artificial detention ponds and conveyed to the sea through stormwater pipes and drains.

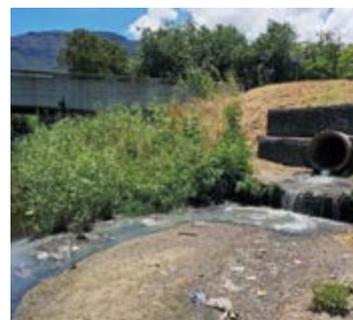
Stormwater discharged into a river, Hout Bay

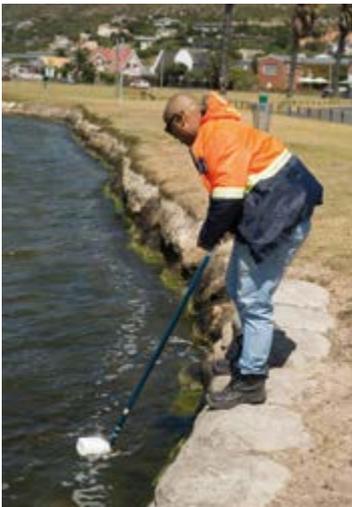
Water quality samples being collected from Zandvlei

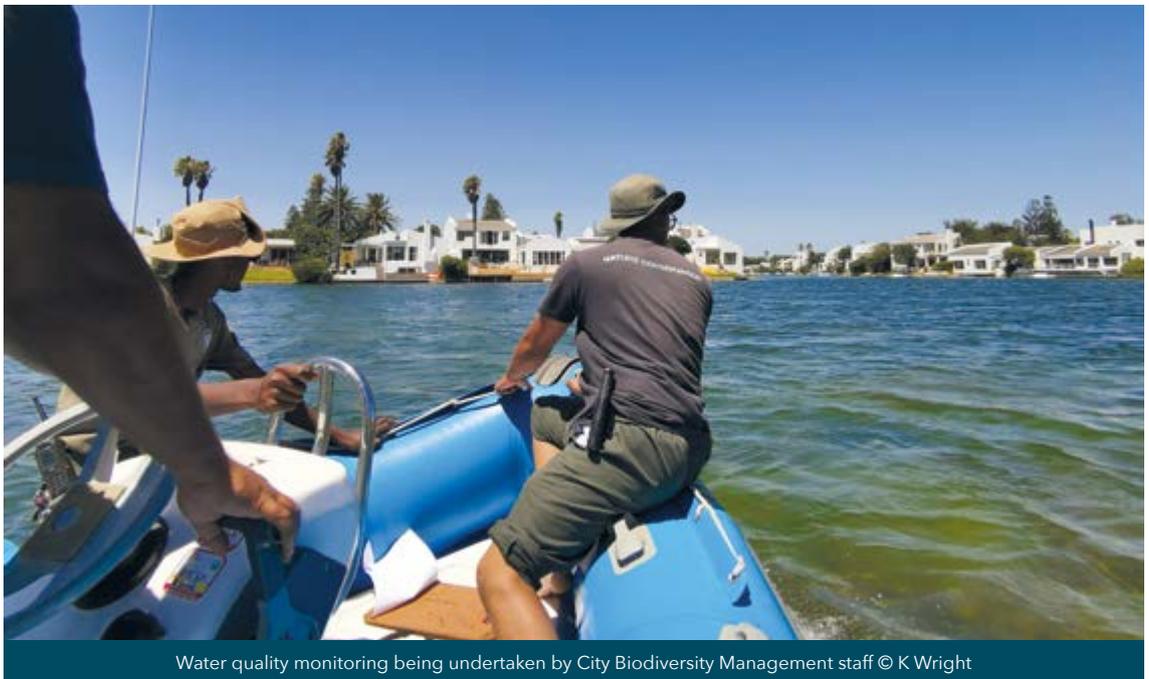
**Figure 4: Long-term trend in *E. coli* levels at rivers and vleis/dams, 1990-2020**

Figure 4 on page 26 indicates the long-term trend in *E. coli* levels measured at all rivers and vleis/dams over approximately 30 years (1990 to 2020). At both rivers and vleis, the general assessment reveals a decline in the percentage of samples that were at acceptable or tolerable levels for intermediate-recreational contact over the 30-year period.

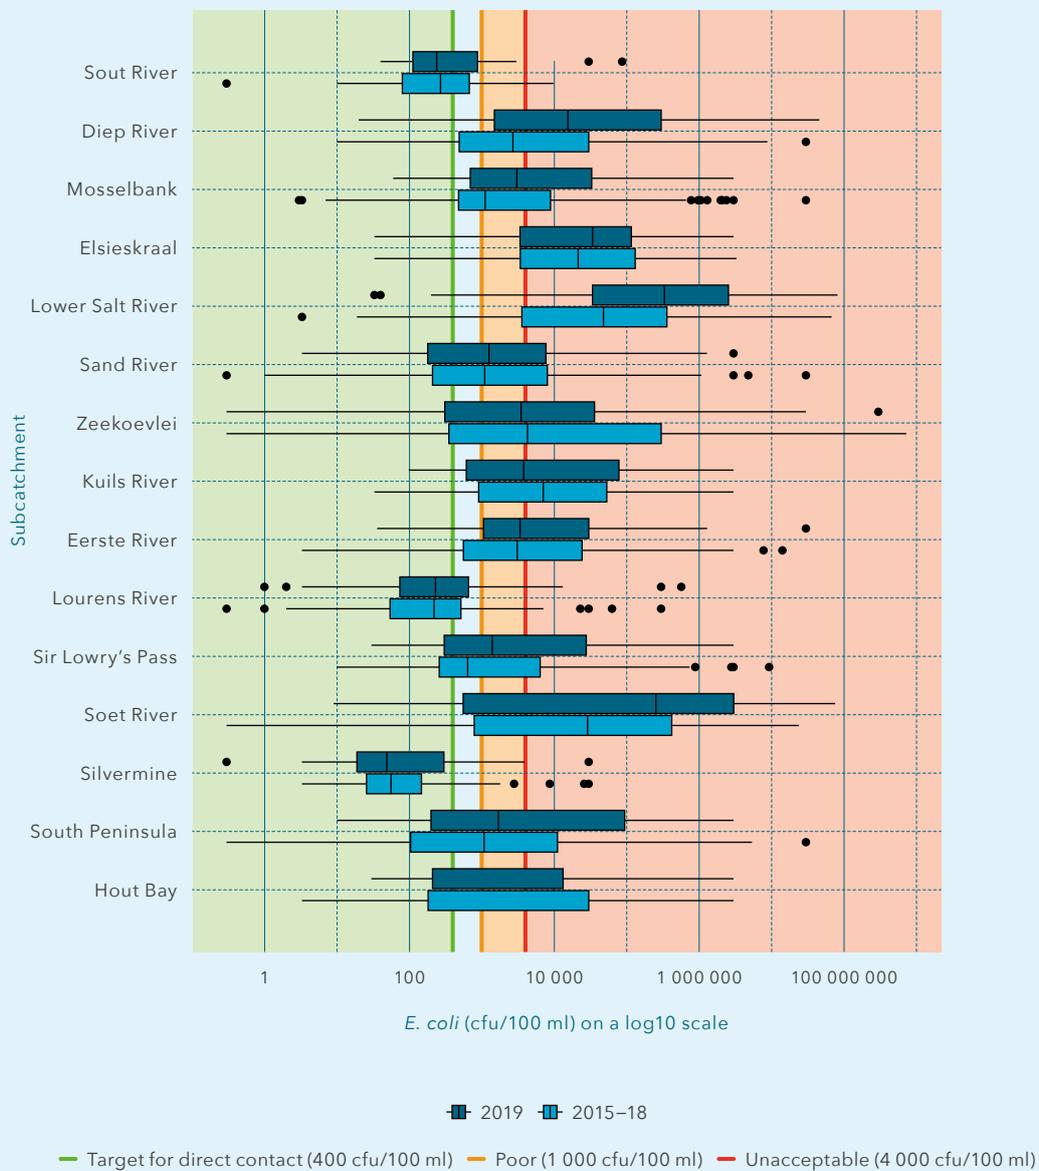
Figure 5a: Comparison of *E. coli* data for 2019 and 2015-2018 (rivers)

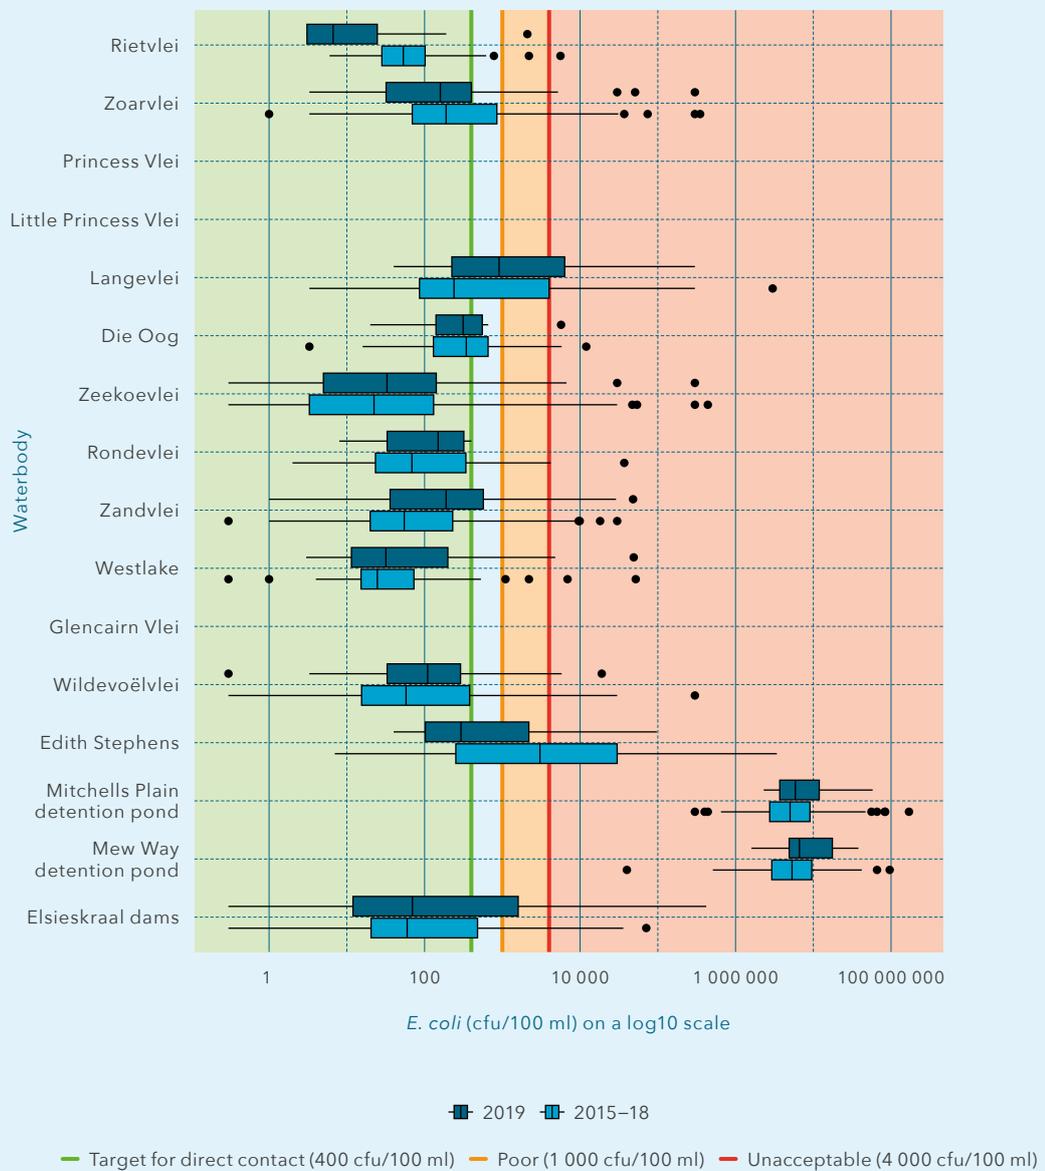
**Figure 5b: Comparison of *E. coli* data for 2019 and 2015-2018 (vleis and dams)**

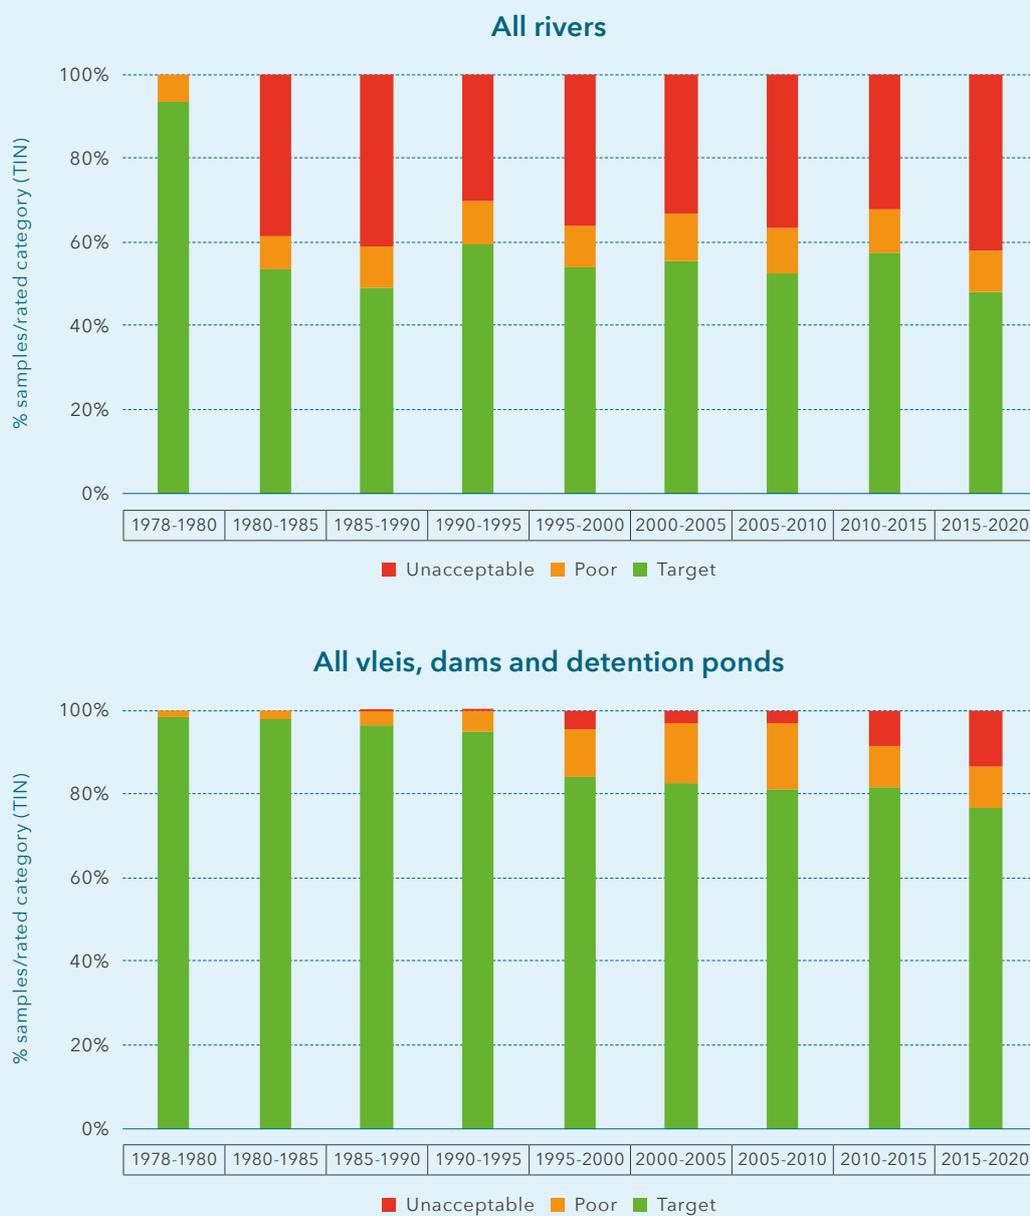
**Figure 7: Long-term trend in nitrogen enrichment at rivers and vleis/dams, 1978-2020**

Nevertheless, the data also show that standing waterbodies (along with the rivers or stormwater systems that feed them) are characterised by low nitrogen:phosphorus ratios, which are likely to promote blue-green algal dominance in many of these systems. The least affected systems are Zandvlei, Little Princess Vlei and Princess Vlei, and the trend in all systems is one of increasing phosphorus relative to nitrogen. This is considered likely to increase the possibility of blue-green algae dominating standing water systems and, under certain conditions, to give rise to blue-green algal blooms.

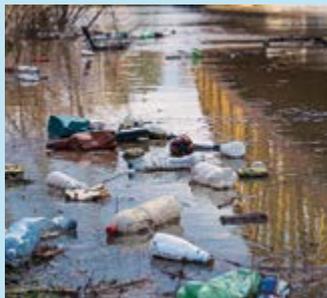
Figure 10: Causes of inland water pollution

**Human behaviour:** What we put into the sewer and stormwater systems, and what we throw away.

To this end, the City has established the Water Quality Improvement Programme (WQIP). This strategic intervention seeks to improve "ambient water quality", which the United Nations defines as natural, untreated water that is affected by a combination of natural influences, anthropogenic activities and other causes of pollution (depicted in figure 10).

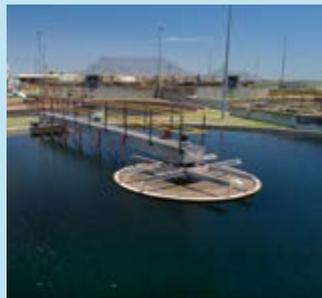
**Sewer collection and wastewater treatment system:** Capacity and operations.

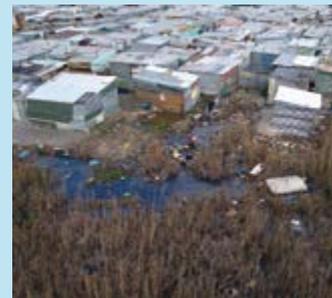
**Informality:** Settlement patterns, urbanisation and poverty.

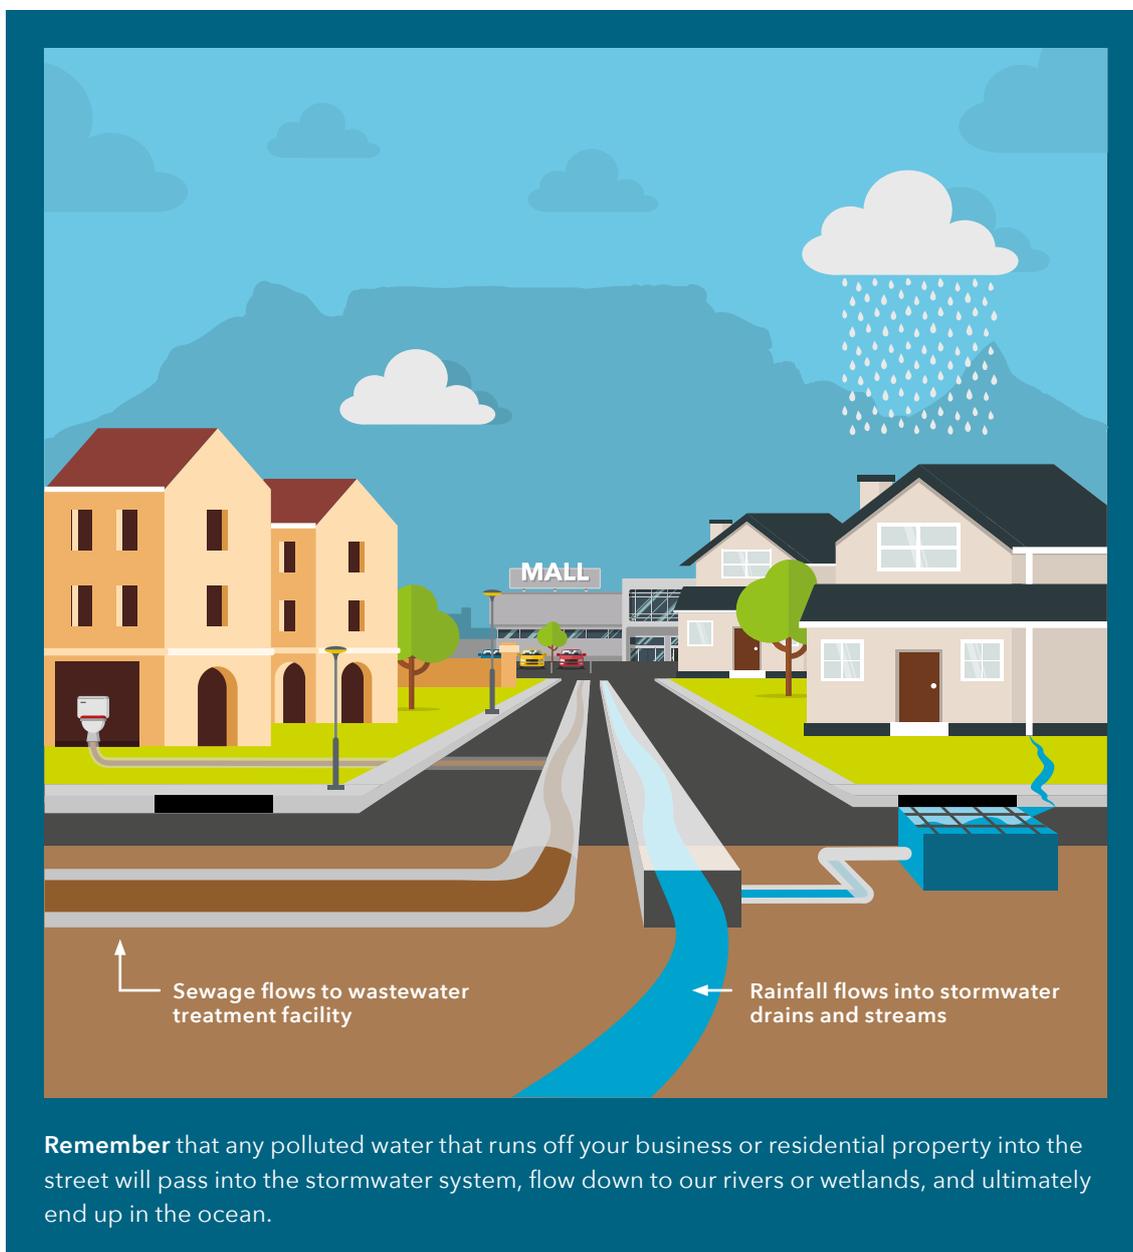
**Understand** the difference between the City's sewage and stormwater networks. Did you know that a stormwater manhole may have holes in the lid, while a sewer manhole cover is always solid?

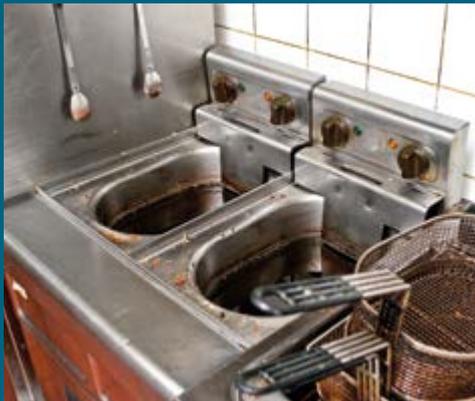
Restaurants should regularly clean out grease traps. The build-up of fats in the sewer system is a major cause of blockages and sewer overflows.
