P WMA 12/T30/00/5212/10

FEASIBILITY STUDY FOR THE MZIMVUBU WATER PROJECT

GEOTECHNICAL INVESTIGATIONS: NTABELANGA, SOMABADI AND THABENG DAM SITES

Report title: **Geotechnical Investigations: Ntabelanga Dam**

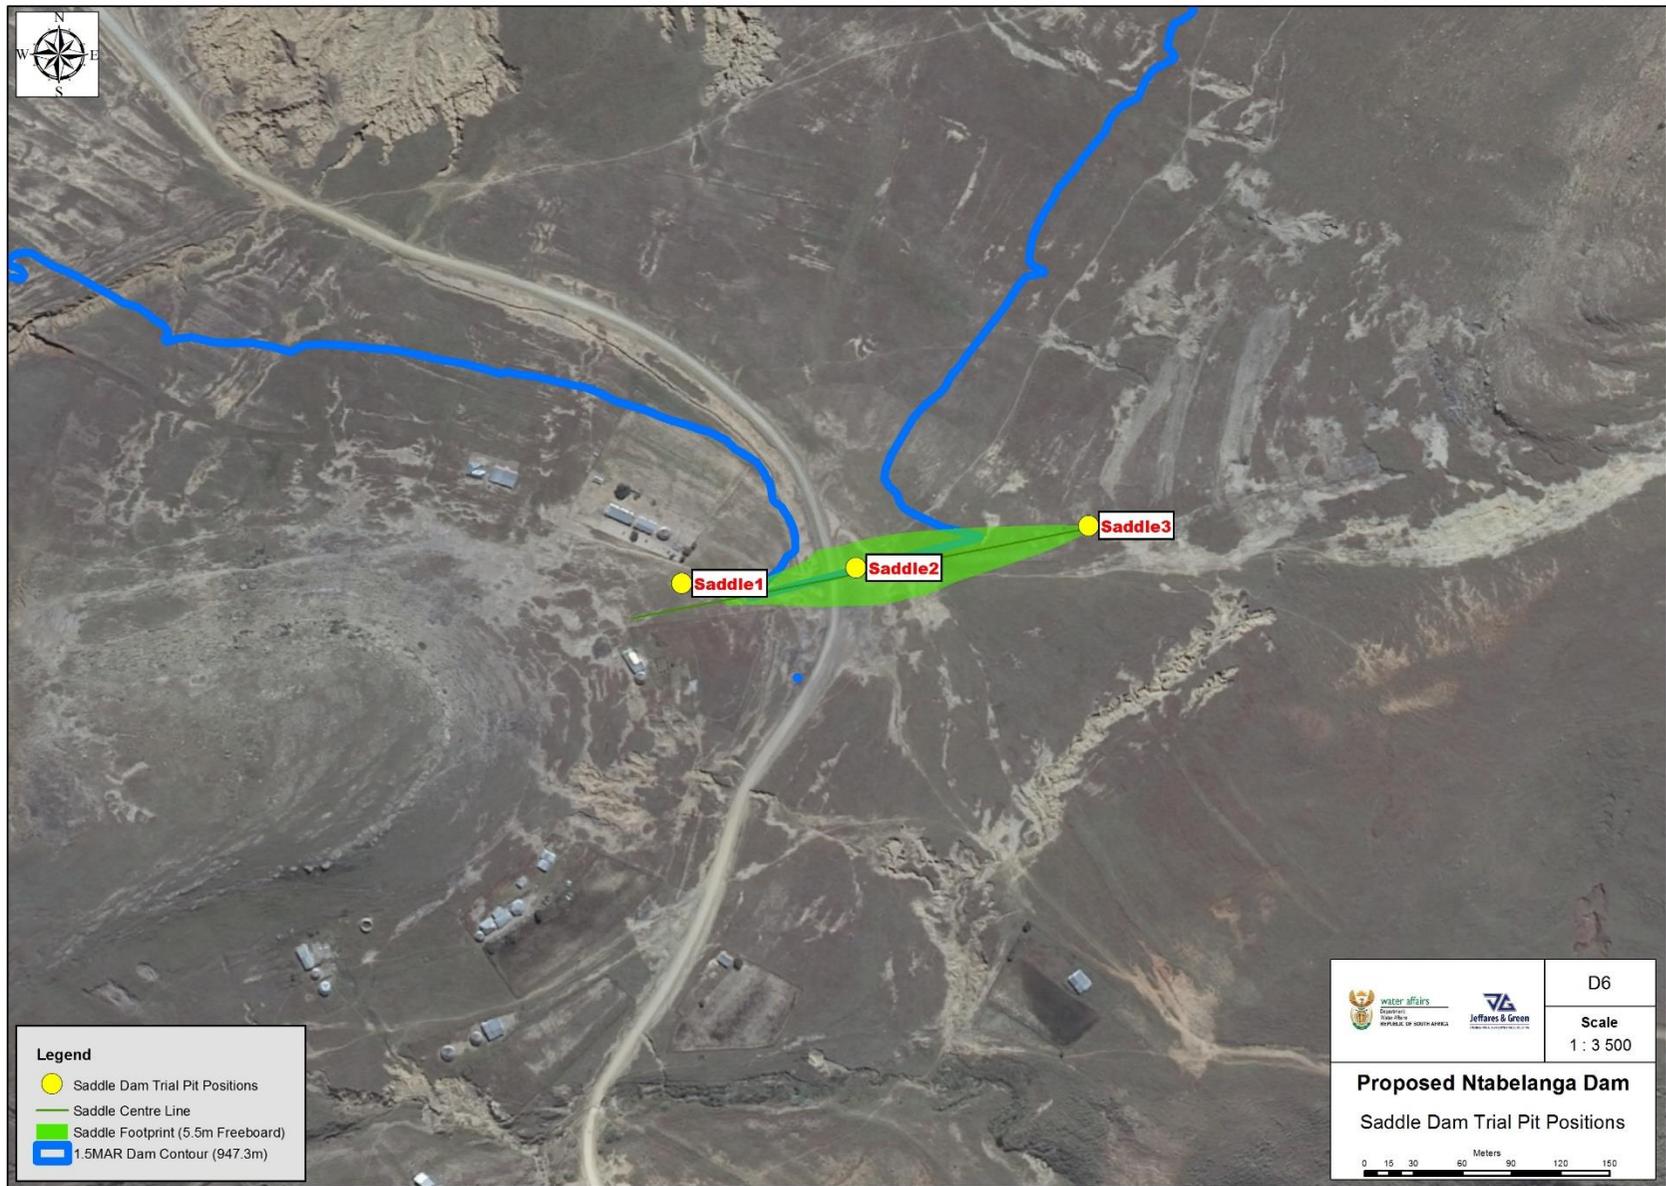
Figure 3-5: Possible Saddle Dam and Trial Pit Positions

- Trial pit Saddle 3 was excavated on the north eastern extremity of the saddle dam axis. The trial pit intersected highly weathered, soft rock, sandstone at a depth of 1.3 m. The rock progressively became medium hard and difficult excavation was experienced at a depth of 1.6 m.
-

- The three trial pits excavated for the saddle dam indicate good founding at shallow depth. As design criteria pertaining to the saddle dam are not known, the need or otherwise for grouting cannot be commented on at this stage.
